Randle Ranger Residence (Building #1135)  
Silverbrook Road  
Randle  
Lewis County  
Washington

HABS No. WA-187

HISTORIC AMERICAN BUILDING SURVEY  
RANDLE RANGER RESIDENCE (Building No. 1135) HABS No. WA-187

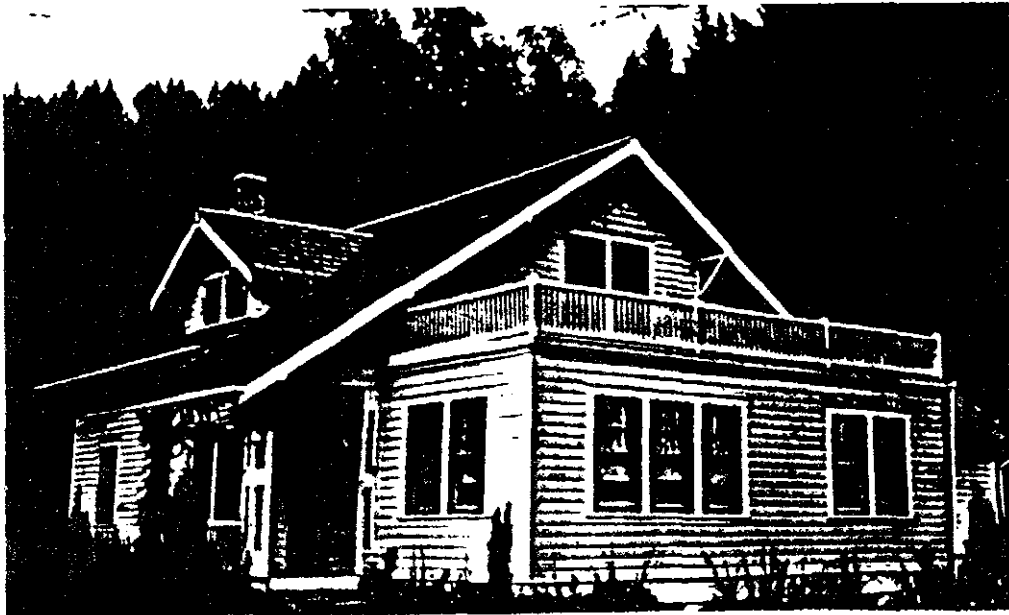
1937 photograph showing the 1936 addition to east side of Randle Ranger Residence. View is to NW.

A number of changes were noted that are not documented in Forest Service records. The present chimney, which services a brick living room fireplace, also appears in the 1937 photograph of the house. A former chimney was found behind a wall in the kitchen. This chimney probably serviced a woodburning cookstove in the kitchen. The 1937 photo also shows a colonial-style railing over the flat-roofed living room/dinette addition. This was removed in later years and a single pitch roof added. In the 1930s the roof of the residence was comprised of cedar shingles. These were replaced in 1950 with composition shingles.
